Funding Reserve Analysis *for* Sierra Country Club Building/Grounds Level 3a Study 2022

August 18, 2021

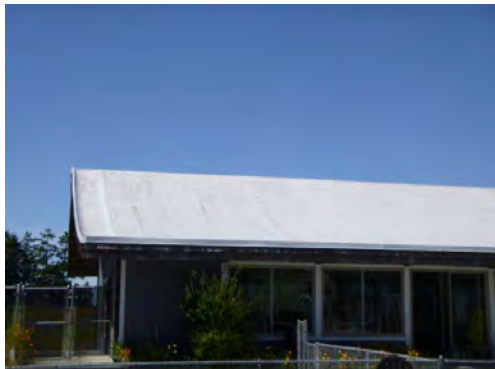
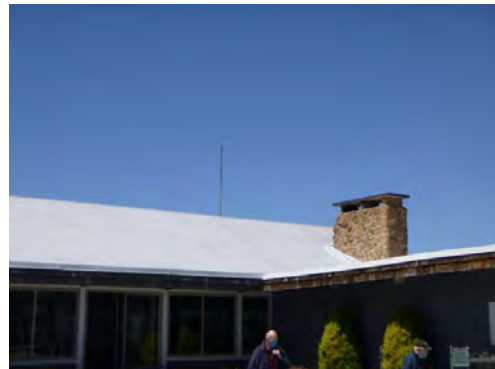
Main Building - Flat & Sloped Roof - 2027

The existing roofing appears to be a touchdown type material that recently had a silver paint-on coating applied. This type of material generally will provide a useful life of 15-20 years if properly maintained. We recommend the association consider installation of a membrane type material. TPO is a type of membrane roofing suitable for flat and low-slope roofs. In the building trades, the acronym TPO stands for thermoplastic polyolefin, a material originally developed for pond liners and used extensively for roofing since 1989.

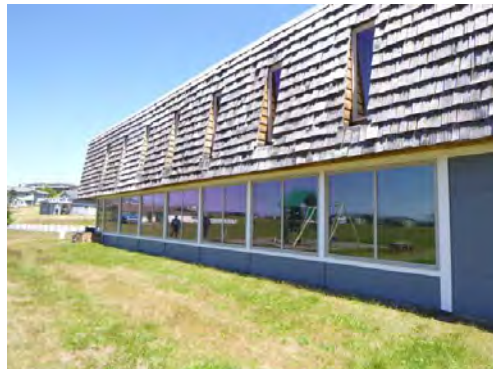
Main Building - Wood Shakes Roof continued...

A portion of the roof is a mansard style with wood shakes. This type of installation should provide a 20-30 year useful life. The association may want to explore other types of material that would require less maintenance and provide a longer life span.

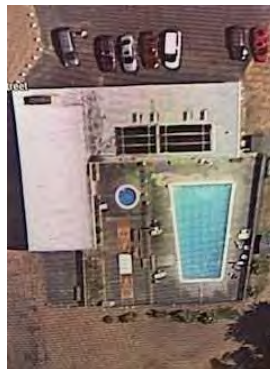
Solar Pool Heating Panel Replacement - 2023

Industry longevity standard for solar pool heating panels is 10-12 years if well maintained. The budget includes funds for replacement of the panels and the various components required.

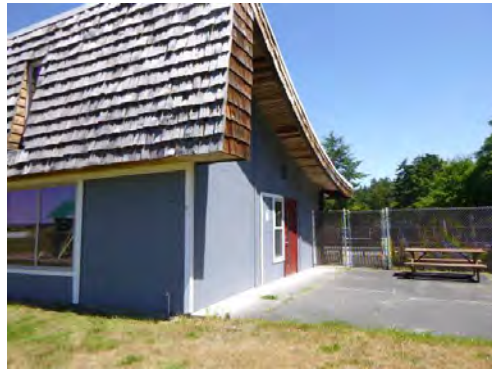
Siding Major Repair/Replacement - 2028

There did not appear to be existing issues with the siding or trim at present. However these materials are susceptible to deterioration and rot if not well maintained. The budget includes funds for the eventual repair or replacement of trim materials and siding when required.

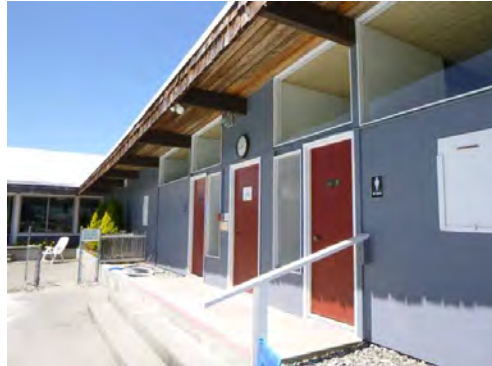
Exterior Paint continued...

Exterior paint is the barrier coat that seals and protects the building materials from the elements. Modern paints when professionally applied over properly prepared materials should provide a useful life of 10 years or more. Inspection and touchup of any damaged areas will greatly increase the performance of these products.

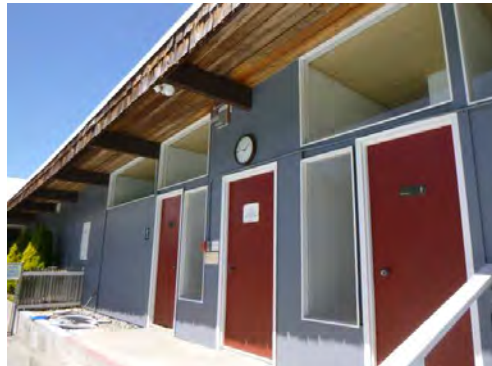
Exterior Door & Window Repair/Replacement - 2026

It was reported that all of the windows and most of the exterior doors have been replaced recently and are of high quality. The bathrooms and utility room doors will require replacement in the near future. The budget includes funds for this replacement and a general fund for repairs and replacement as needed.

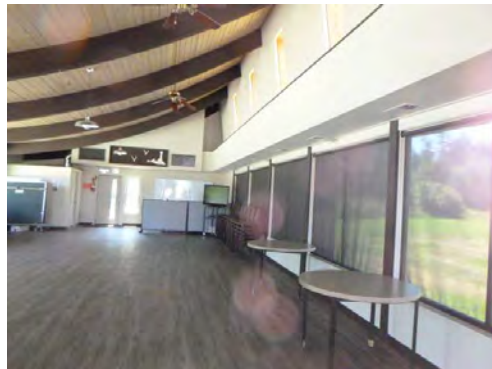
Interior Paint - 2029

The interior was last painted in 2017 and appears to be in good condition. Interior paint should provide a useful life or 10-15 years depending on paint quality, application and amount of usage of the facility.

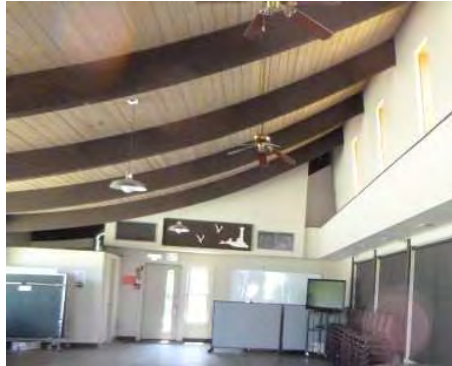
Lighting & Fan Replacement continued...

The exterior and interior light fixtures appear to be in good condition. Most light fixtures will last approximately 20 years before requiring replacement. With more efficient fixtures and bulbs generally operation costs can be dramatically reduced. The interior ceiling fans should be cleaned and inspected annually and should provide 20 or more years of service. The budget includes funds for replacement with comparable modern lighting fixtures and fans.

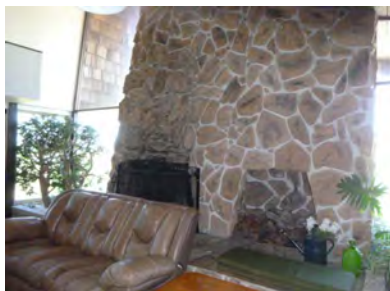
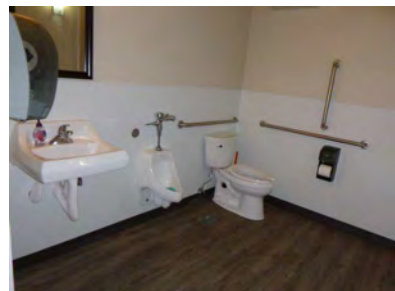
Interior Update - 2031

Asset ID	1009	1 Allowance @	\$12,500.00
	Main Building	Asset Actual Cost	\$12,500.00
	Interior Update	Percent Replacement	100%
Placed in Service	January 2017	Future Cost	\$19,391.60
Useful Life	15		
Adjustment	-1		
Replacement Year	2031		
Remaining Life	9

Funds are provided for updating the interior of the main building in 15 year cycles or as needed. Kitchen

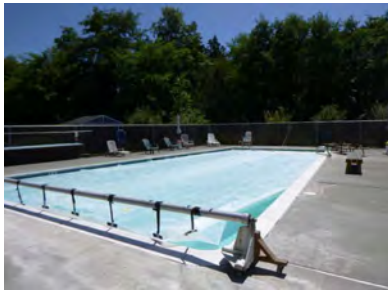
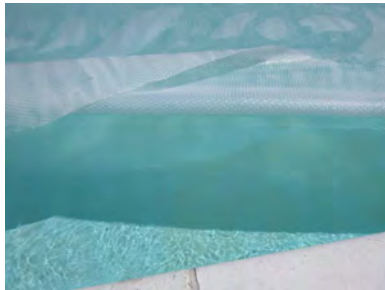
Pool Major Repair/Replaster - 2022

The pool appears to be in reasonable condition however the surface is rough and indicates re-plastering will be required to avoid more significant expenses in the future.

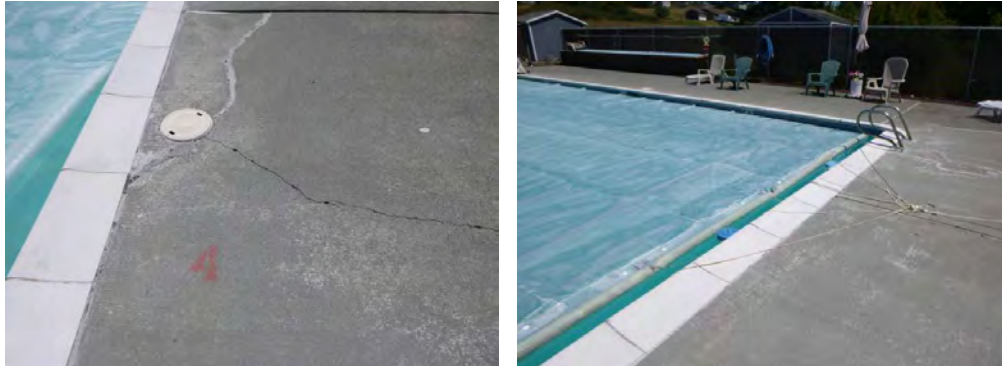
Pool Deck Repair continued...

The pool deck shows some cracking that should be repaired to minimize future costly repairs. Areas should be inspected to determine if panels require replacement or simply crack seal application.

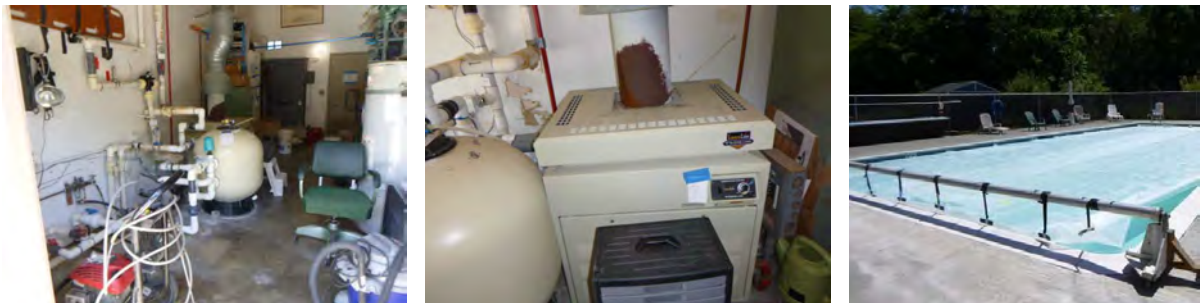
Pool Equipment Major Repair/Replacement - 2025

Pools have a variety of equipment including pumps, filtration components, heating system and an off season pool cover. The budget includes funds for these various item major repair or replacement.

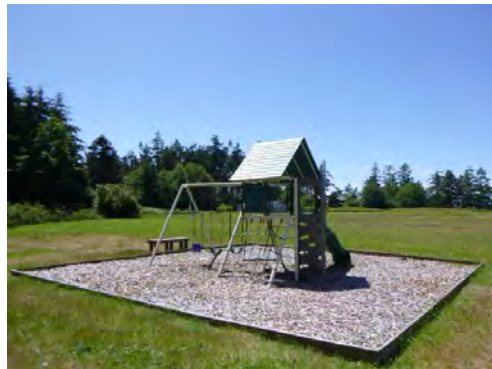
Play Structure Major Repair/Replacement - 2024

The play structure appears to be in reasonable condition however replacement will be required. Seasonal inspection and repair recommended.

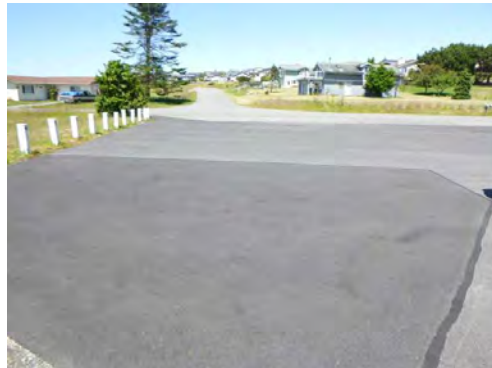
Asphalt Paved Parking Lot - Repair - 2029

The asphalt paved areas appear to be in good overall condition. Regular cycles of repair and seal coat application are the most cost-effective program for the long-term care of asphalt, forestalling a much more costly resurface project. Water penetration is the largest contributor to deterioration. Recommend inspection and repair of any cracks followed by application of a quality seal coat by a reputable contractor as part of routine maintenance.

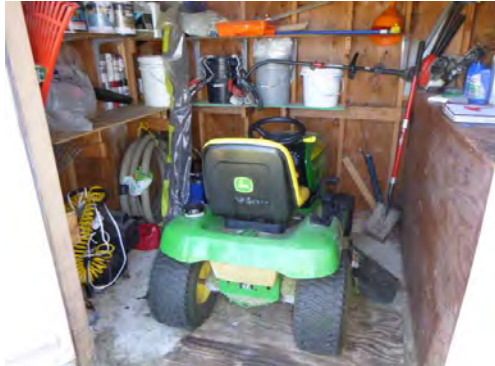
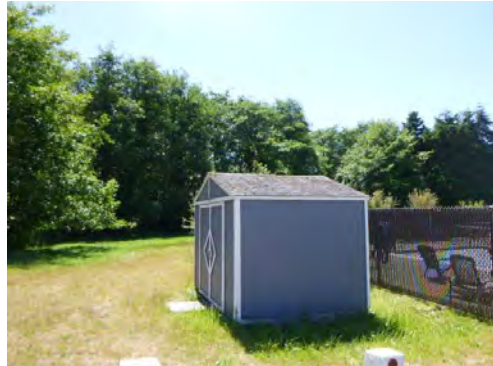
Grounds Maintenance Equipment & Shed continued...

The budget includes funds for repair and replacement of the community lawn mower, associated equipment and the storage shed.

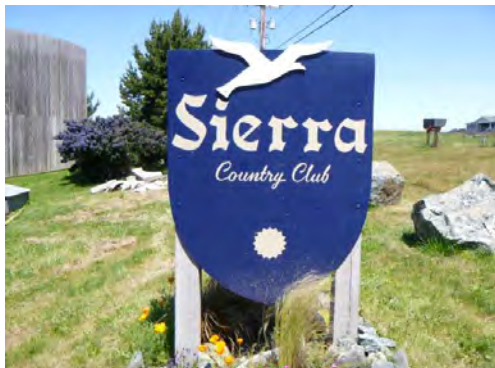
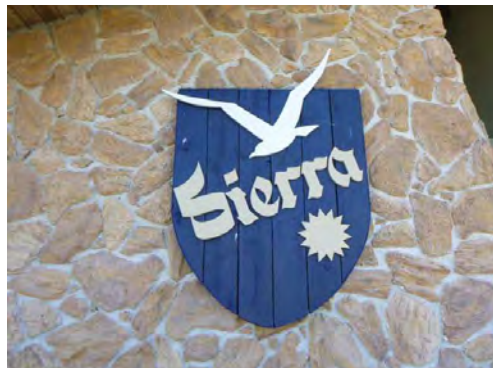
Signage Major Repair/Replacement - 2025

Asset ID	1018	1 Allowance	@ \$2,500.00
	Main Building	Asset Actual Cost	\$2,500.00
	Signs	Percent Replacement	100%
Placed in Service	January 2015	Future Cost	\$2,894.06
Useful Life	10		
Replacement Year	2025		
Remaining Life	3
